# 1981 ENVIRONMENTAL MONITORING REPORT U.S. DEPARTMENT OF ENERGY FACILITIES GRAND JUNCTION, COLORADO AND MONTICELLO, UTAH

# Field Engineering Corporation

**April 1982**

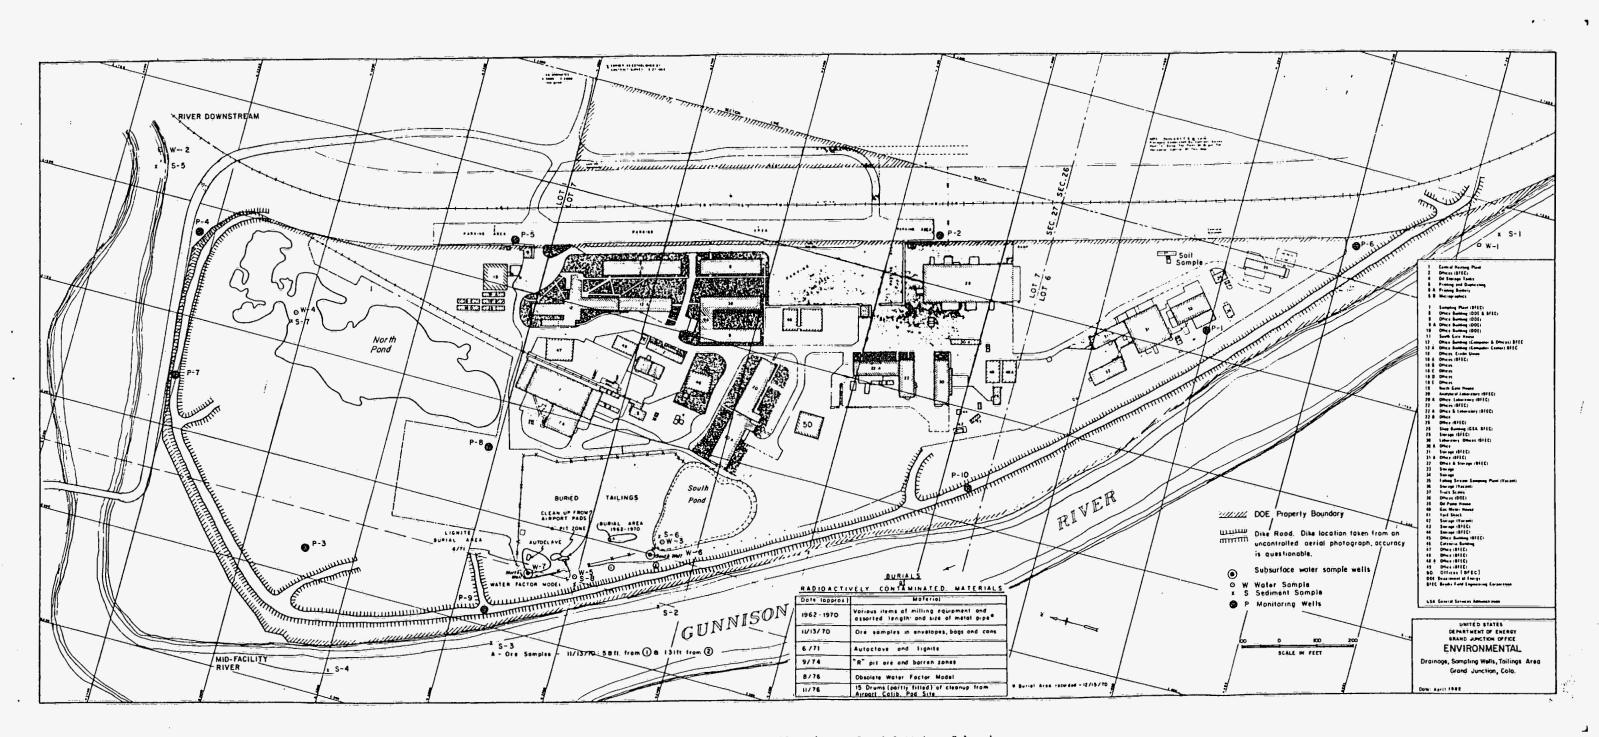
Figure 1. Drainage, Sampling Wells, Tailings Area = Grand Junction, Colorado

North Pond: The analyses of water samples taken from the North Pond reflects high concentrations of radium and uranium when compared to EPA standards. These result from past burial of contaminated materials. The actual source and quantity of material buried is unknown. Formerly, the pond received a small amount of sewage wastes but now only receives some storm runoff.

Drainage Ditch: The water in the contained drainage ditch along the west boundary of the facility is the most highly contaminated surface site. Tailings from the nearby "buried tailings area" were either dumped in the ditch or have leached into it. The ditch receives some overflow from the South Pond but the water level seems primarily to rise and fall with the river level. The ditch lies outside of the facility fence and is within a large dike alongside the river. Arsenic, molybdenum, uranium, and radium all exceed EPA criteria with the latter being 300 times the standard.

The locations of the new monitoring wells are shown in Figure 1. Drill holes P-1 and P-2 were expected to provide background information. Holes, P-3, P-4, P-6, P-7, P-9, and P-10 should provide information on contaminant movement below the dike and possibly into the river. Hole P-8 was placed in the center of the facility near the buried tailings area. Hole P-5 is in the excavation for a sewage lift station just outside the facility's east boundary.

Piezometers #2 and #6 are sampling background. All of the other piezometers display contamination. (All of the shallow piezometers and #5 were dry at the time of sampling.) Of most interest are piezometers 4, 7, 9, and 10 which are within 10 to 25 feet of the river. Gross alpha, Ra, Se, Mo, V, As, and U are all found in concentrations exceeding EPA interim standards in one or more or these wells. Mo contamination is particularly high with the concentration being as much as 50 times EPA standards.

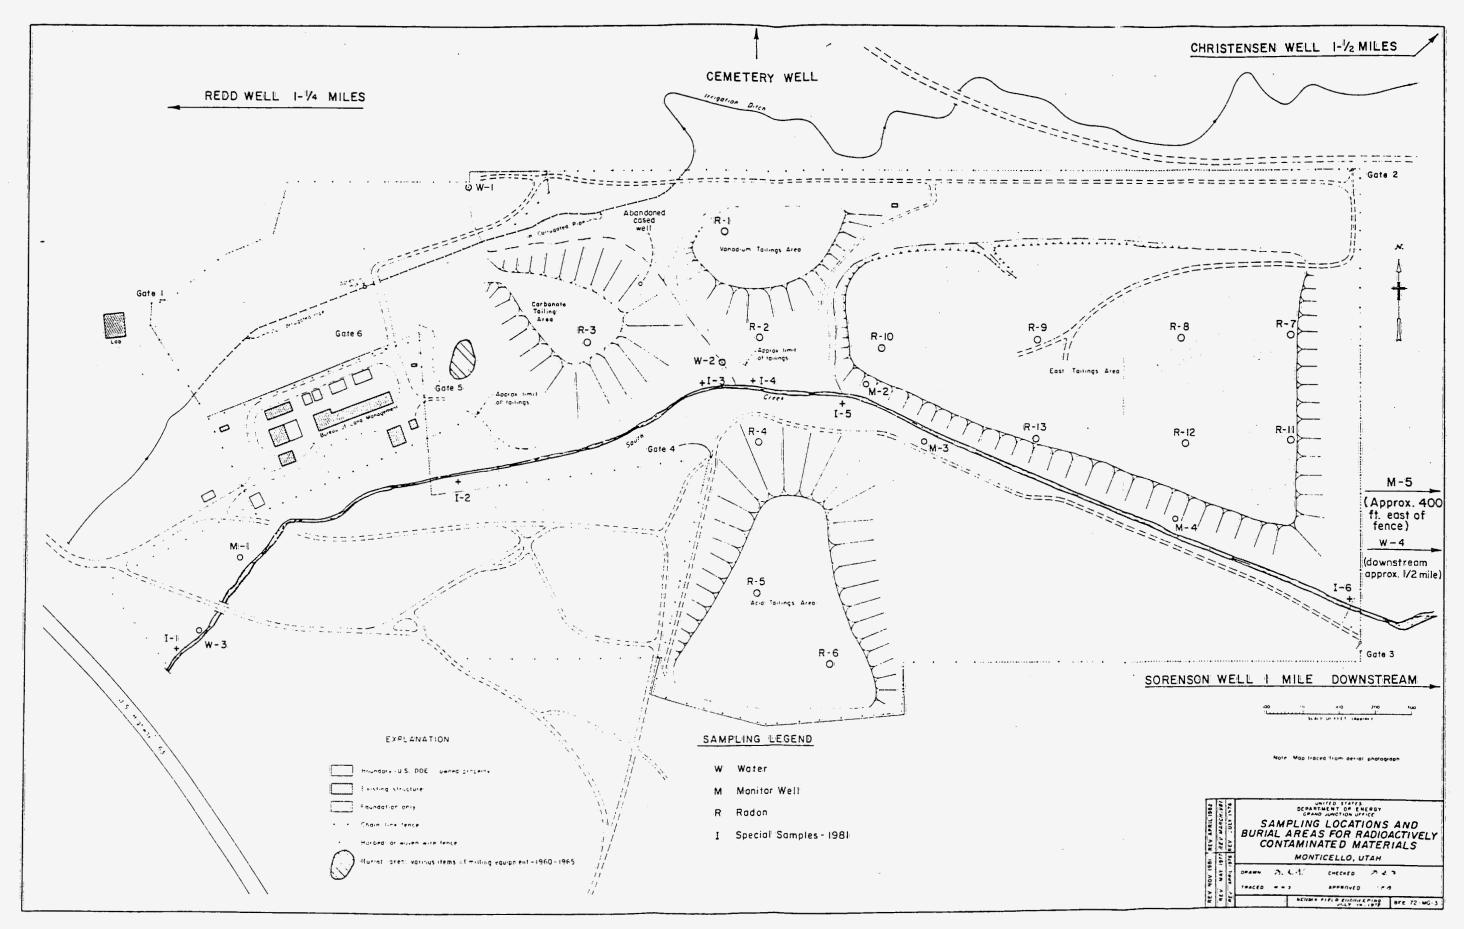
Figure 2. Sampling Locations and Burial Areas for Radioactively Contaminated Materials - Monticello, Utah

Radon measurements were made on top of the covered tailings at Monticello during 1981 using the Radon-ON-Activated-Charcoal (ROAC) method. The sampling points are shown on Figure 2, and the average radon flux for samples collected on the tailings piles are shown in Table 7. Obviously, the radon emanation far exceeds the EPA interim standard of  $2 \text{ pCi/m}^2$ 's. The actual emanation of the tailings is significantly attenuated by the overburden. The piles, however, continue to erode, and seepage at their base leads not only to increased water pollution but also to increased radon emanation as more tailings are exposed by leaching.

Sample location W-2 is a permanent seep between the vanadium and carbonate piles. The sample is collected approximately 5 feet from where this seep discharges into the creek. This particular sample is always highly contaminated; however, a significant variation in concentration is evident. For example, the uranium concentration ranges from 10 to 100 times the EPA interim standard. The standards are also exceeded for arsenic, molybdenum, selenium, and nitrate. There is no standard for vanadium, however, its concentration exceeds background by a factor of 10,000.

Contamination of the creek is evident even prior to the creek's traverse of the actual tailings piles. The sample I-2 taken immediately west of the carbonate pile is downstream from the old mill area. Uranium and vanadium are both contaminating this sample. Prior to the seep entering the creek at W-2, the carbonate pile only contributes vanadium which increases by a factor of four. After W-2, the concentrations of arsenic, molybdenum, vanadium, and uranium increase significantly. The next sample was collected immediately past the vanadium pile. Uranium, molybdenum, selenium, vanadium, and radium all continued to increase. At the east end of the property, arsenic and vanadium all reach their maximum value while uranium decreases slightly. An additional mile downstream, molybdenum and uranium reach their highest concentrations at the Sorenson site. This is evidence that the alluvial aquifer, as mentioned previously, contaminates the creek beyond the tailings area boundary.
